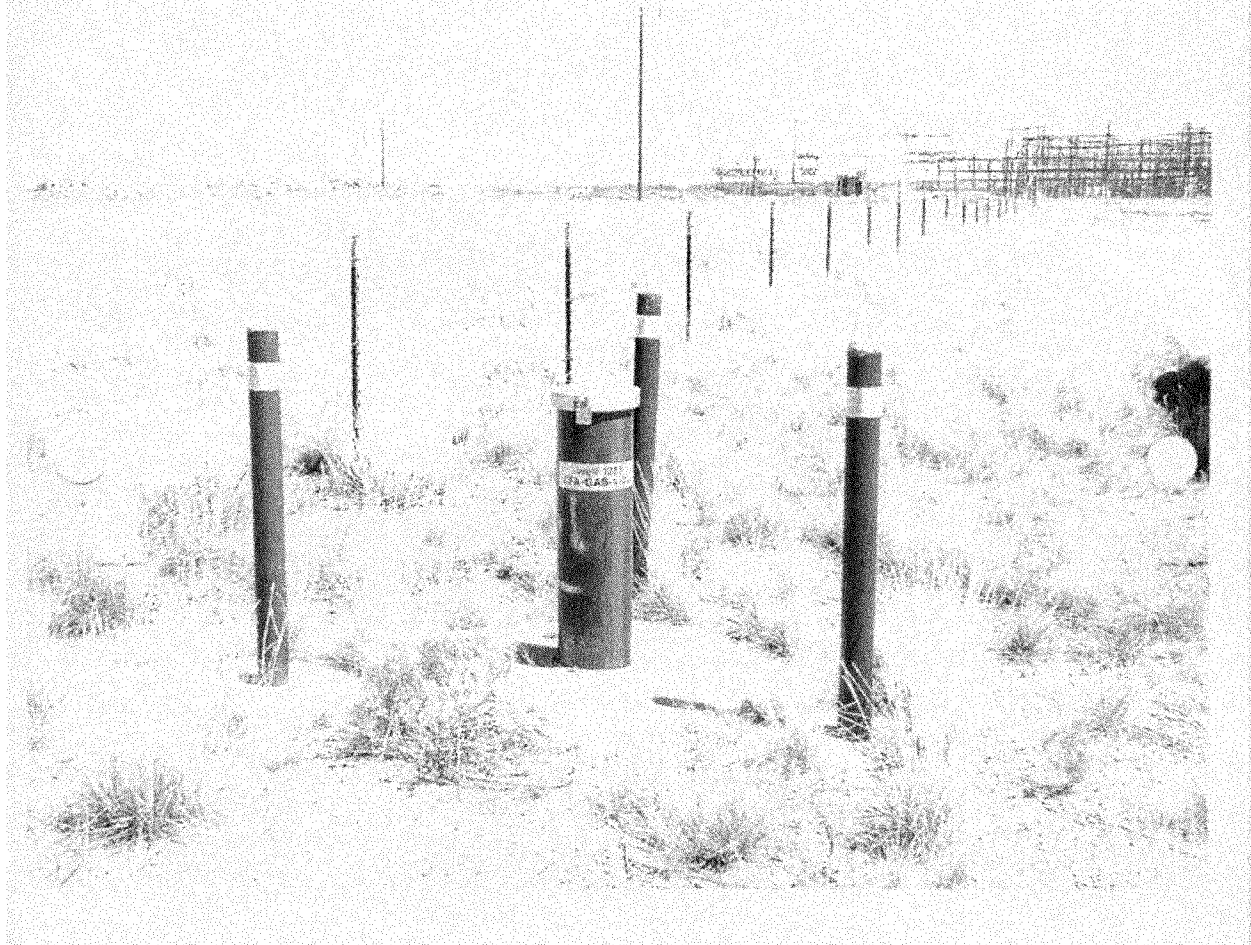
Well ID: 1255
Well Name: CFA-645-V-005
Date of Photo: May 2, 2001
File: ... \CFA\1255 May 2 01.jpg

Measuring point		Yes	No	If other, what is it	
Is the water level measuring point marked		<input checked="" type="checkbox"/>	<input checked="" type="checkbox"/>	Surface Pad	
If yes, how "X" on N. side (M.P.)				Is a concrete pad present	
Stick up		Inches		If yes, describe the condition	
Stick up of surface casing above concrete pad		2 ft + 8 in		Good	
Stick up of well casing stick up above the pad		22 in		Survey	
Stick up of water access pipe above the pad				Is a survey (brass) marker present	
Stick up of water discharge pipe above the pad				If yes, what is recorded	
Describe the general condition of the well		Good		GSP2-01	
[4 gas vapor) ports on 2" steel carrier pipe inside protect casing]				NA027	
Additional comments/Other hazards at the well				Northing 682849.49	
				Easting 294688.85	
				Elev 4930.63	
Checklist prepared by (print) R Garcia		Checklist reviewed by (print) Wendell Jolley			
Signature: [Signature]		Date: 5/2/01		Signature: [Signature] Date: 5/11/01

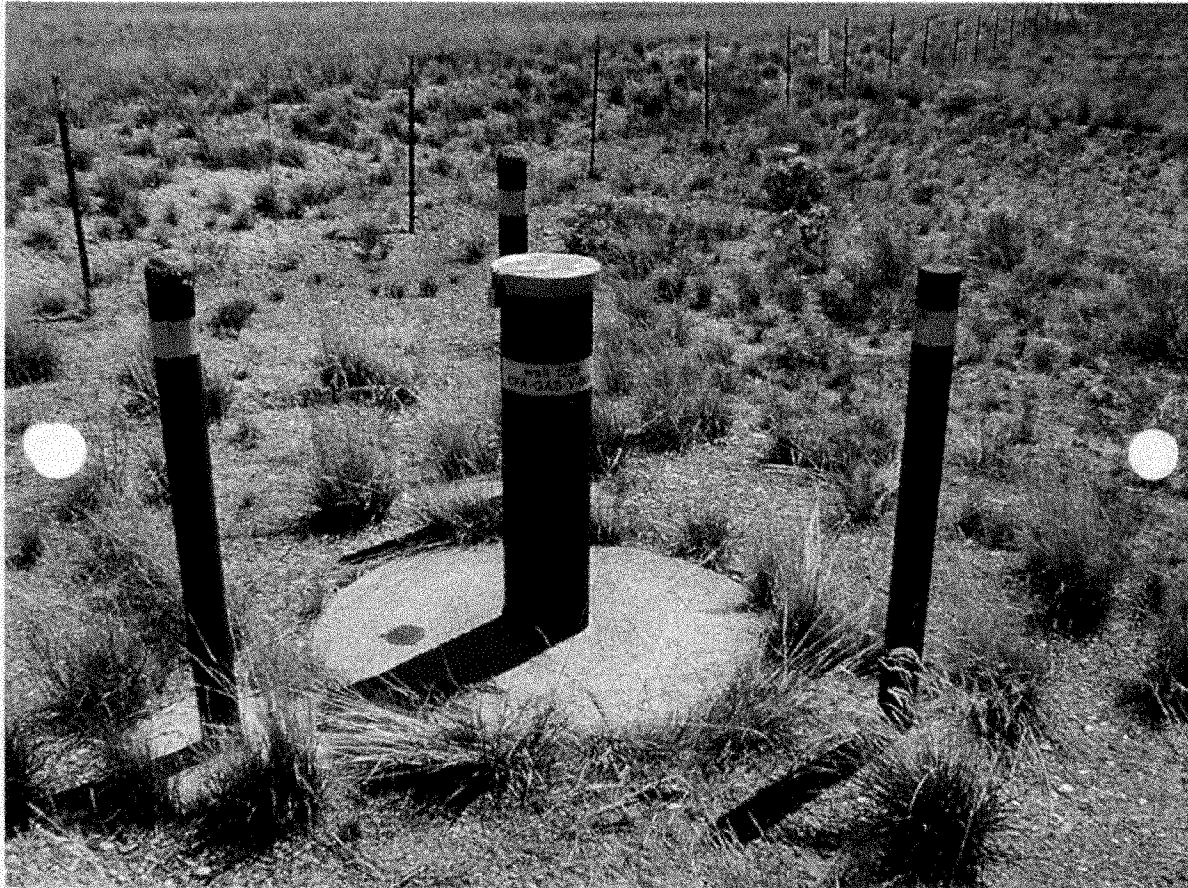
Well ID: 1256
Well Name: CFA-GAS-V-006
Date of Photo: May 3, 2001
File: ... \CFA\1256 May 3 01.jpg

Measuring point		Yes	No	Surface Pad	
Is the water level measuring point marked		<input checked="" type="checkbox"/>	<input checked="" type="checkbox"/>	Is a concrete pad present	
If yes, how "X" or E side (M.P.)				If yes, describe the condition	
Stick up		Inches		Good	
Stick up of surface casing above concrete pad		3 ft 1 in			
Stick up of well casing stick up above the pad		26 in		Survey	
Stick up of water access pipe above the pad				Is a survey (brass) marker present	
Stick up of water discharge pipe above the pad				If yes, what is recorded	
Describe the general condition of the well		Good		GSP2-02	
4 vapor ports inside protective casing				Northing 683639.07	
attached to 2" carrier (metal) pipe				Easting 294128.07	
Additional comments/Other hazards at the well				Elev. 4933.51	
Checklist prepared by (print) R. Garcia		Checklist reviewed by (print) Wendell Jolley			
Signature: <i>R. Garcia</i>		Signature: <i>Wendell Jolley</i>

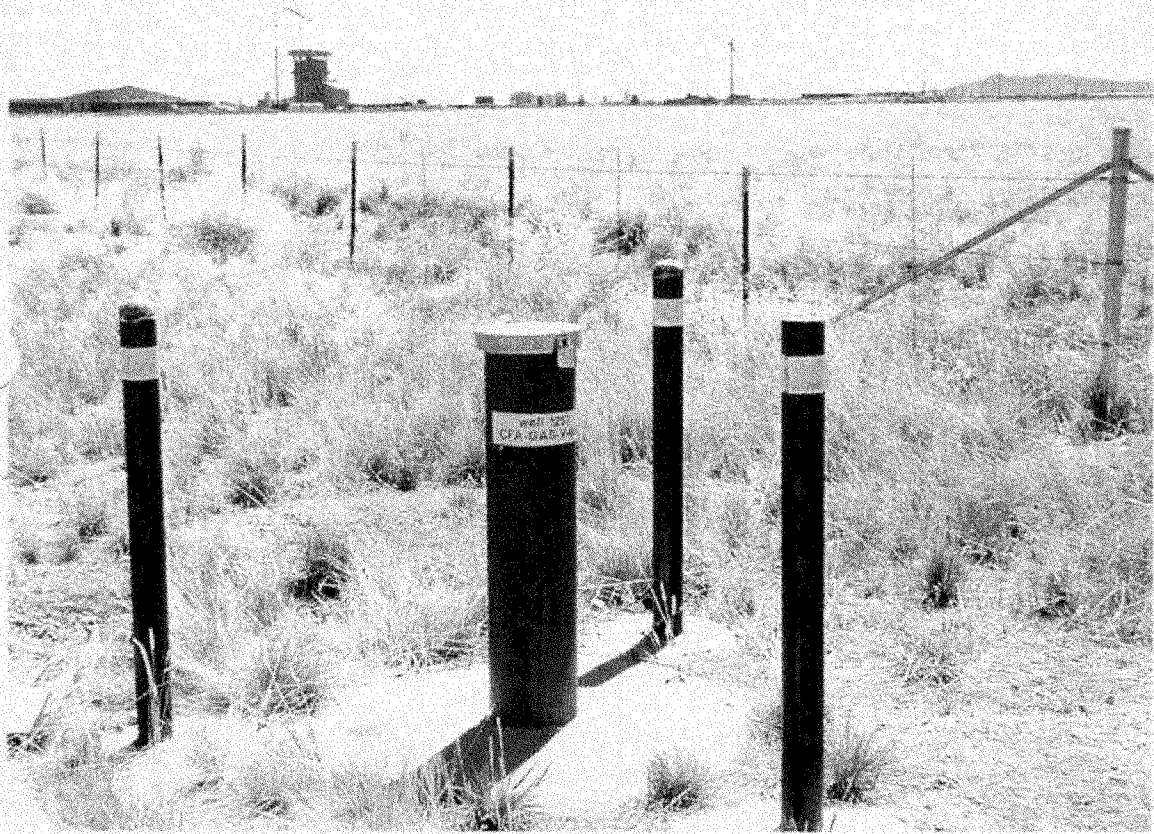
Well ID: 1257

Describe the condition of the cap <u>Good</u>					
Can well be accessed without unlocking, and if so, how (ie unbolt the cap) <u>No</u>					
Locks		Yes	No	Electrical	
Is the well locked upon departure		<input checked="" type="checkbox"/>		Is an electrical plug present	
Identify the condition of the lock <u>New</u>				What type of plug is present (volts, amps)	
Identify the type (mfr) of lock, and the lock number					
<u>American Lock QEE</u>					
Protective Posts		Yes	No	Photographs	
Are protective posts present		<input checked="" type="checkbox"/>		Was the well photographed	
If yes, are post painted yellow			<input checked="" type="checkbox"/>	What camera was used <u>Canon 2</u>	
If yes, how many (circle one) 1 2 <u>3</u> 4 5				Which smart card are the photos on <u>1</u> 2 3	
Is at least one post removable		<input checked="" type="checkbox"/>		List the photograph numbers <u>8</u>	
Describe the condition of the posts <u>Good</u>				<u>Photo to 3</u>

Stick up of water discharge pipe above the pad		-		<u>NA027 coordinates</u>	
Describe the general condition of the well <u>Good</u>				<u>Northing 683893.79</u>	
<u>4 vapor ports on 2" metal carrier pipe</u>				<u>Easting 291968.15</u>	
Additional comments/Other hazards at the well				<u>Elev 4939.04</u>	
<u>Old lock was cut upon arrival. W3 5/7/01</u>					
Checklist prepared by (print) <u>R Garcia</u>		Checklist reviewed by (print) <u>Wendell Jolley</u>			
Signature: <u>[Signature]</u>		Date: <u>5/3/01</u>		Signature: <u>[Signature]</u> Date: <u>5/7/01</u>

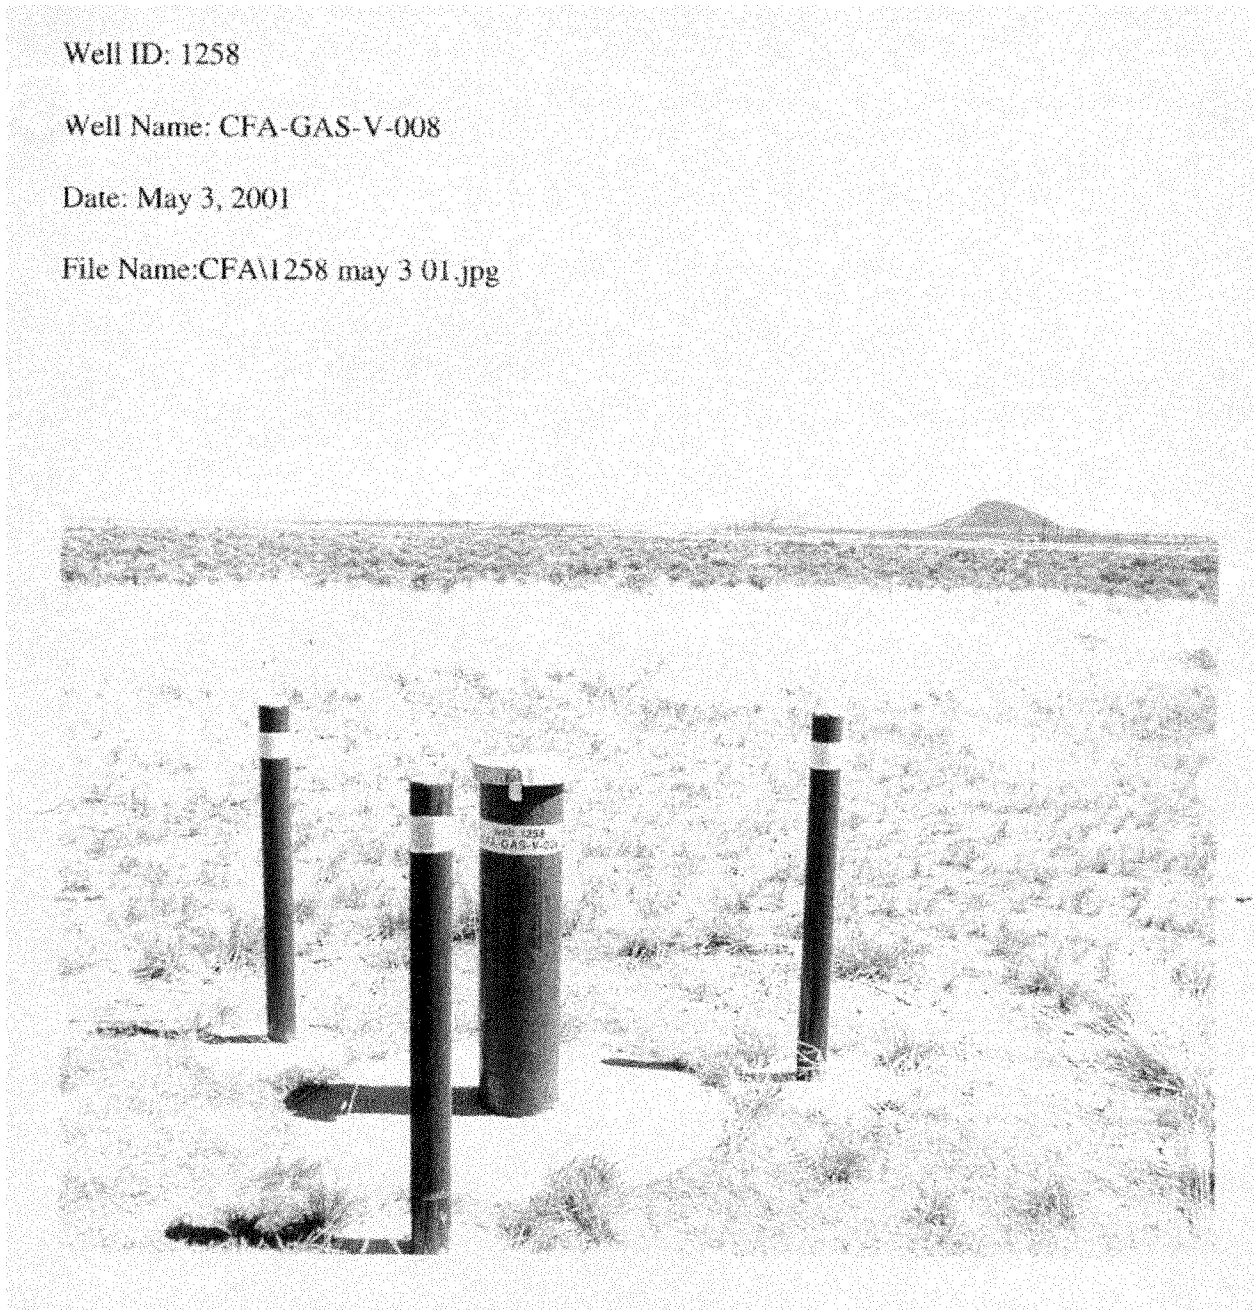
Well ID: 1258

How is it attached (circle one)		Welded	<input checked="" type="checkbox"/> Bolted		
Describe the condition of the cap Good					
Can well be accessed without unlocking, and if so, how (ie unbolt the cap) No					
Locks		Yes	No	Electrical	
Is the well locked upon departure		<input checked="" type="checkbox"/>		Is an electrical plug present	
Identify the condition of the lock New				What type of plug is present (volts, amps)	
Identify the type (mfr) of lock, and the lock number					
American Lock EE					
Protective Posts		Yes	No	Photographs	
Are protective posts present		<input checked="" type="checkbox"/>		Was the well photographed	
If yes, are post painted yellow			<input checked="" type="checkbox"/>	What camera was used	
If yes, how many (circle one)		1	2	3	4
Is at least one post removable		<input checked="" type="checkbox"/>		Which smart card are the photos on	
Describe the condition of the posts Good				List the photograph numbers

Describe the general condition of the well excellent				GSP3-02	
4 vapor ports on 2" metal casing pipe				NORTHING 684927.13	
inside protect. surf. casing				EASTING 292096.75	
Additional comments/Other hazards at the well				ELEV 4937.42	
Checklist prepared by (print) R Garcia		Checklist reviewed by (print) Wendell Jolley			
Signature: [Signature]		Signature: [Signature]		Date: 5/3/01
